Recreation Centre

Service Delivery – Energy Audit – Final Report

Project Location: Township of Chapleau

Wood Project Number: BE20102014

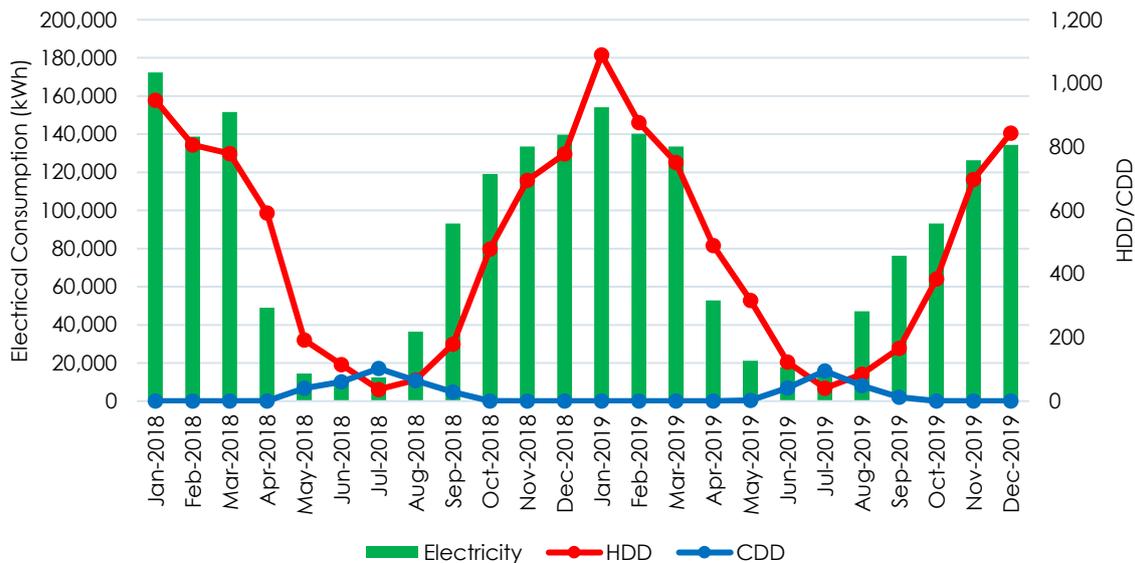
Figure 3-1 Monthly Electricity Consumption

The figure shows that electricity consumption tends to have the highest peaks in the winter months; this is to be expected for a building in a heating dominated climate that has sources of electric heating and a large process load which is a contributor during the winter period represented by the ice plant. There is approximately a 20,000 kWh baseload between May and July consisting of lighting and plug loads.

To establish a baseline year, a linear regression analysis (R-squared analysis) was completed on the electricity data. The R-square value is a measure of the degree of correlated agreement between the electricity consumed and the dependent variable chosen, in this case CDD and HDD. An R-squared value of 1 represents a perfect correlation, while a lower value indicates a lesser degree of influence between the variables. In general, an R-squared value indicates a strong correlation between 0.8 and 1; a moderate correlation between 0.7 and 0.8; and a weak correlation below 0.7. By using an R-squared analysis to correlate energy usage to outdoor temperature, it may be possible to normalize data to a typical year, thereby removing the effects of temporary peaks or lulls due to varying weather patterns and determine how closely energy consumption is related to the weather.

The calculated R-squared of **0.78** for HDD and **0.53** for CDD indicates the facilities electricity consumption is moderately influenced by a dropping outdoor air temperature; This is misleading as the months requiring heating also correspond to the months where the ice plant equipment run frequently for making ice. The correlation between CDD is poor as there is no air conditioning for the complex. As such, the utility data was averaged for each month that was provided and was used as the baseline year.

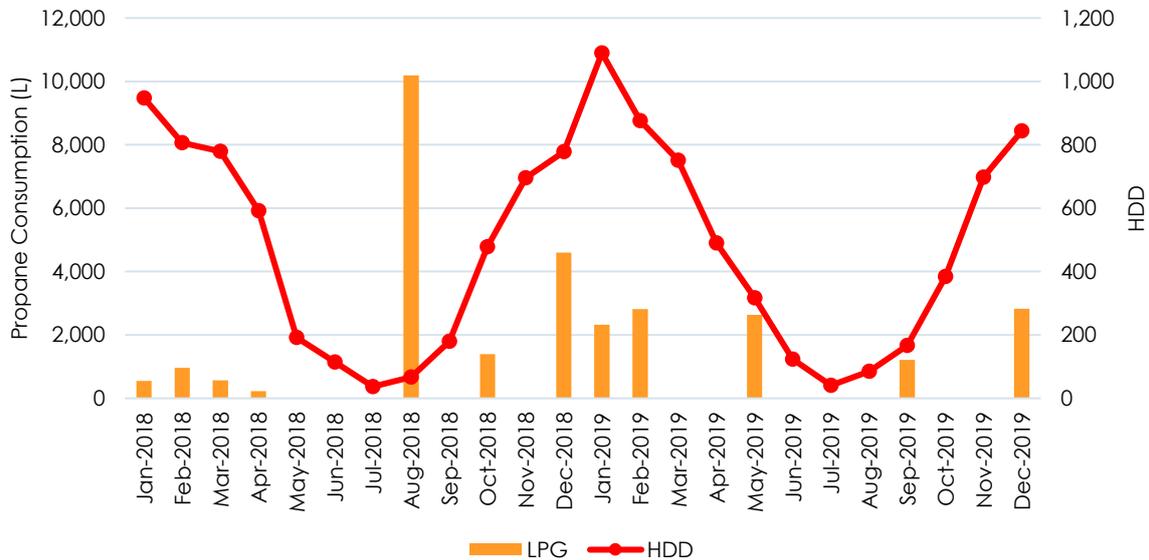
Figure 3-2 Monthly Record of Propane Purchased

As can be seen in the figure above, propane is commonly purchased and used in the winter months; This is to be expected as this is when space heating is required for the facility and ice re-surfacing water is needed for the ice rinks. A large spike occurred in August 2018 and this can be attributed to the period when the renovation was complete and the introduction of propane based MUA unit, furnace and DHW heaters. A linear regression analysis has also been conducted in an effort to establish consumption for a typical year. The calculated R-squared value of **0.001** indicates a weak correlation between fuel consumption and HDD; This is due to the fact this data is based on bulk purchase and not actual monthly consumption. As such, the utility data was averaged for each month that was provided and was used as the baseline year.

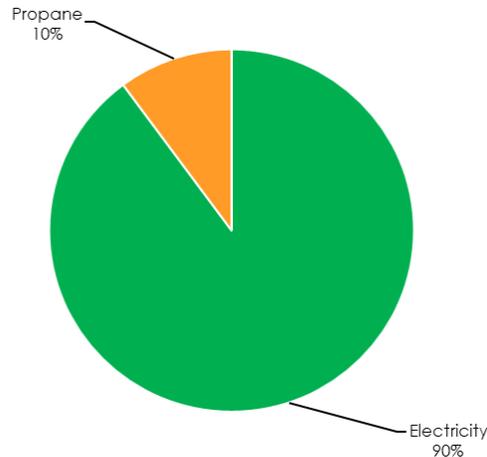
Figure 3-3 Annual Energy (GJ) Consumption Breakdown by Fuel Type

Electricity has been estimated to account for approximately 90% of all energy consumed at a cost of \$146,743 while propane accounts for the other 10% at a cost of \$9,625. The cost per energy metric for propane and electricity at the used rates are \$23.37/GJ and \$40.19/GJ respectively.

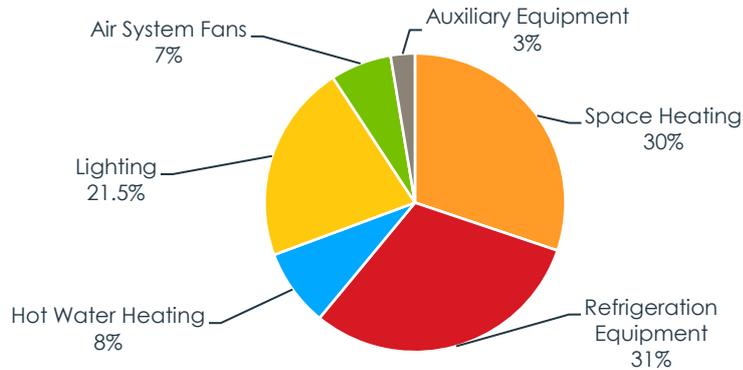
Figure 3-5 Annual Energy Consumption Breakdown by Major End-Use

From the figure, refrigeration and space heating are the end users that consume the most energy at the facility with 31% and 30% respectively. The building recently switched to a propane furnace to heat the community hall but the majority of heating throughout the facility is electric based which represent large energy saving opportunities. The ice plant operates similar to the heating equipment from September to April and is composed of compressors, pumps, and heat rejection equipment which require significant horsepower to operate. Lighting is the next largest end user and the high bay fixtures in the ice and curling rinks consume the majority of electricity in this category. Hot water heating consumes 8% of the energy at the facility with the majority of this portion dedicated to ice re-surfacing. Air system fans represents 7% of the total energy consumed and this includes dehumidification for the ice rink. The remaining 3% is auxiliary equipment.

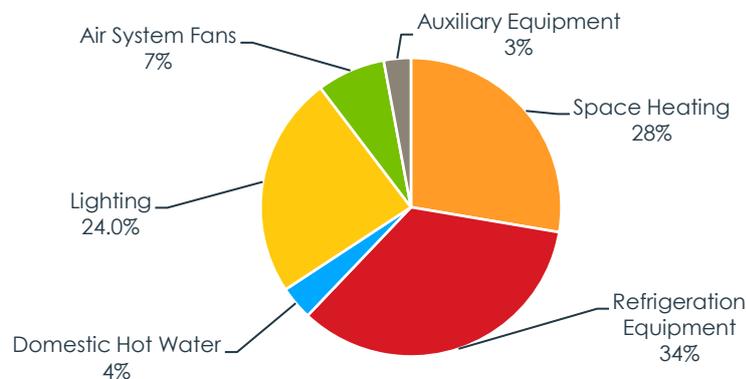
Figure 3-6 Annual Electricity Consumption Breakdown by Major End-Use

An estimation of the electricity consumption by major end-use has been made based on the listing of identified equipment on site, the estimated run hours, and any diversity in use that can be foreseen. The breakdown is shown in the figure below.

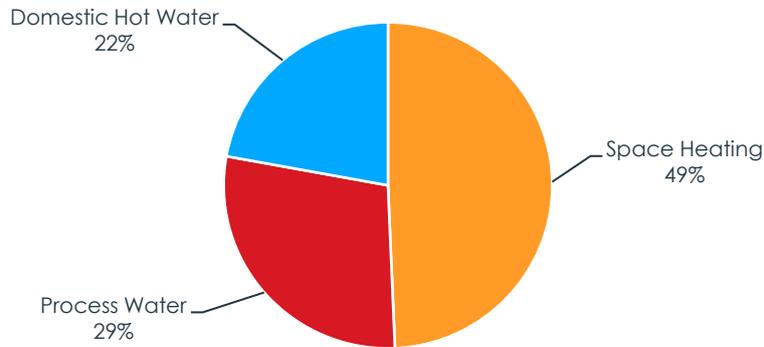
Figure 3-7 Annual Propane Consumption Breakdown by Major End-Use

An estimation of the propane consumption by major end-use has been made based on the listing of identified equipment on site, the estimated run hours, and any diversity in use that can be foreseen. The breakdown is shown in the figure below.
