Public Works Garage

Service Delivery - Energy Audit – Final Report

Project Location: Township of Chapleau

Wood Project Number: BE20102014

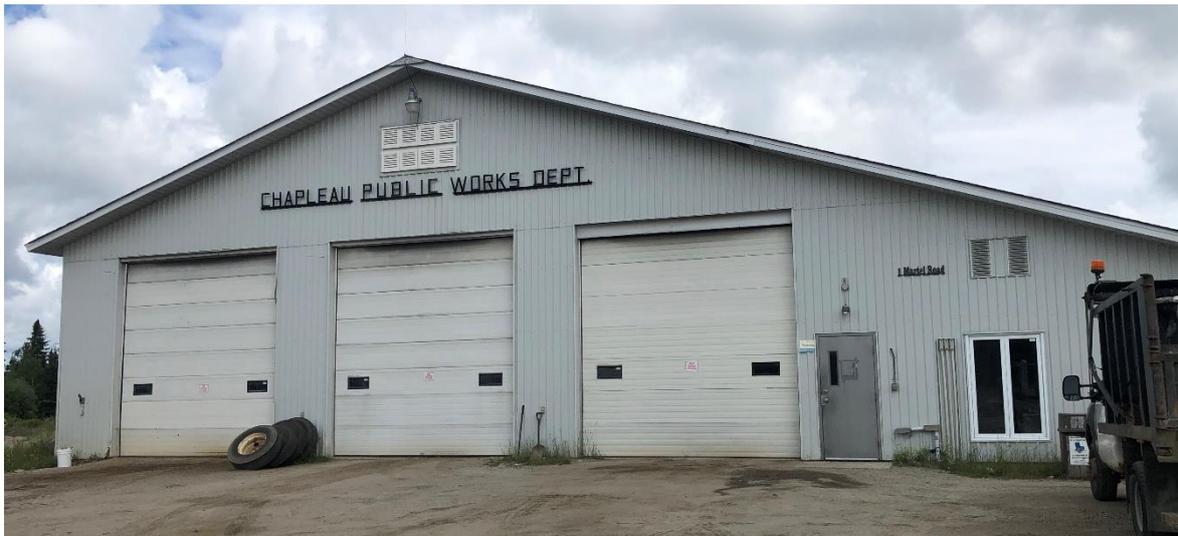
South-West façade

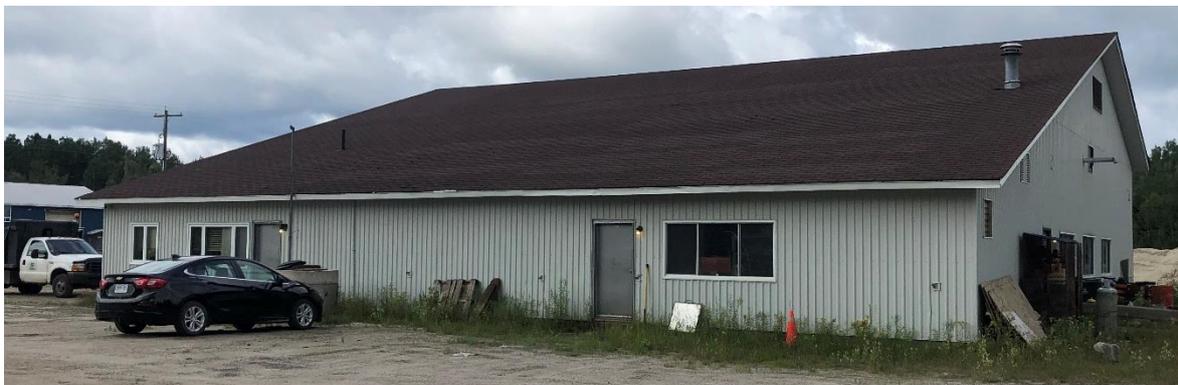
South-East Façade

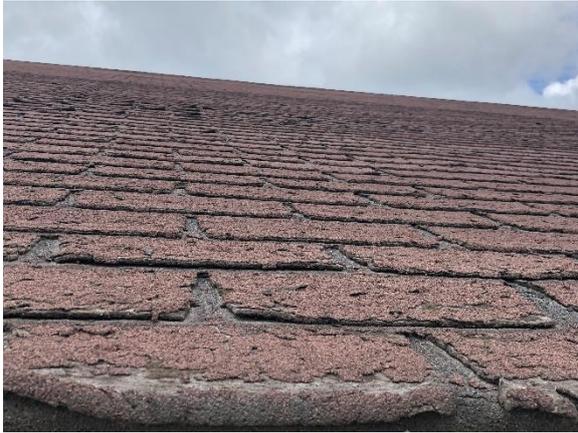
Roof Shingles

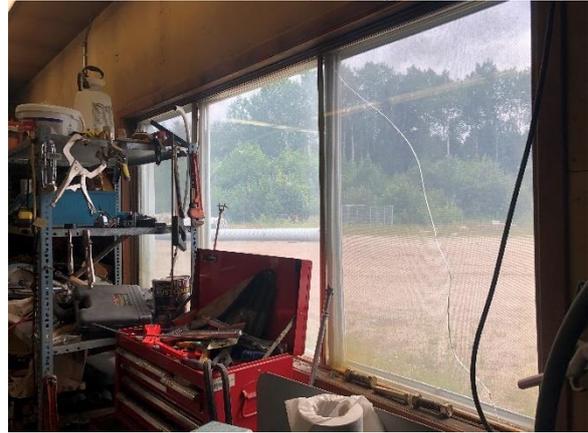
The Facility is a single story slab on grade constructed with structural steel framing and sheet metal wall assemblies. The garage ceiling is 16ft high with an attic space above and pitched roof with asphalt shingles. The storage and shop spaces have an interior gypsum board finish with 8ft ceilings; The office is similar but with plaster and drop ceilings. The windows at the facility are single pane slider except for the office portion which has insulated crank casement windows. A window in the shop room has a cracked pane.

Example of single pane window

The installation or replacement of worn or broken weather stripping, window caulking, and foam sealants can contribute towards reducing air infiltration around doors, windows, piping, cracks, and exhaust/plumbing penetrations. The broken window pane in the shop requires replacement.

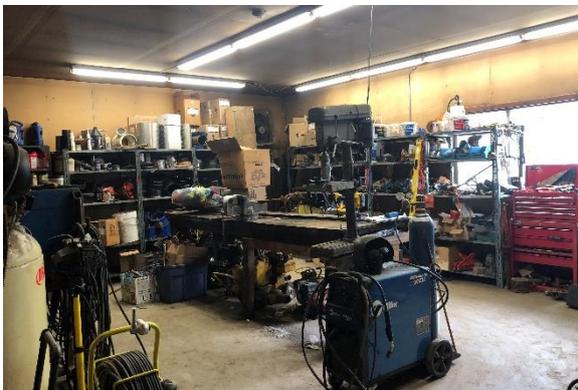
Shop
